## Lessons Learned from Wall Failure

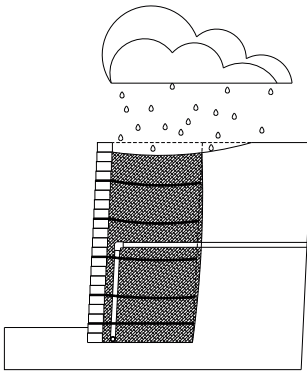
This particular retaining wall was designed by a professional engineer from the residence in need of site work. The design called for a three degree wall with grid lengths of 6 ft (1.8 m) at a maximum spacing of 4 courses for an exposed wall height of approximately 12 ft (3.7 m). A driveway was located at one end of the wall and a gradual slope to the residence located approximately 50 ft (15.2 m) from the back of the wall. A soils report was not obtained but experience indicated that this was a typical clay soil for the area. Little information is available on the method of construction, except that soils were placed in the infill zone in 2 ft (0.61 m) lifts with little if any compaction achieved. The following sequence of events outlines what transpired after the wall was completed.

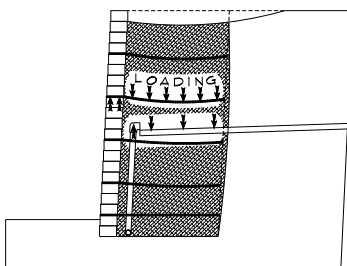
- Heavy rain from the adjacent property saturated the fill area behind the wall. Settlement, averaging 8 in. (20.3 cm), extending approximately 9 ft (2.8 m) behind the wall was experienced because of the lack of water management and the resulting saturation of the soil. Surface water runoff from several lots simply followed a pre-existing grade and stopped at the back of the wall. A drainage outlet was not incorporated into the design.

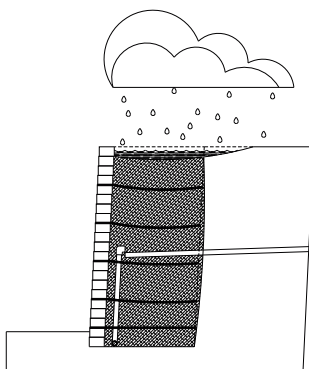
- During the construction care was taken to route down spouts from the house gutters through two, 4 in. (10.2 cm) rigid plastic pipes. Subsequent to the settlement the rigid plastic drain pipes broke directly behind the wall. It can be assumed that during the settlement the geogrid directly behind the wall experienced unanticipated loading, and possible damage, caused by the soil consolidation.

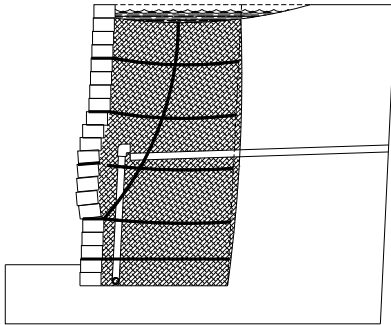
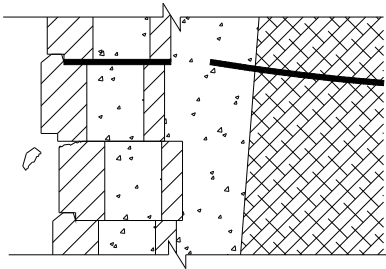
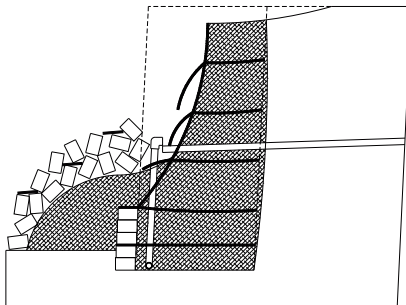
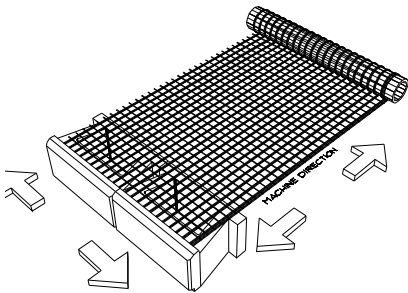
- During frequent rain falls that followed, the settlement area turned into a ponding area, holding water runoff. This inability for the site to effectively drain water away from the soil resulted in constant saturation of the soil.
- Continuing rain fall resulted in an internal stability failure. A localized slip plane materialized, caused by a build up of hydrostatic pressure and by a reduction in strength of the soil. These conditions undoubtedly created a bulge in the wall at approximately 4 ft (1.2 m) above grade.

- With no way of determining what happened next, we can speculate that after an undetermined amount of bulging, shear lips failed at approximately 2 ft (0.61 m) above grade and the geogrid sheared behind the wall at the top three layers of grid. At each layer of grid that failed, a length of approximately 10 in. (25.4 cm) sheared away from the rest of the reinforcement mat.
- An internal failure plane, following a log spiral configuration, resulted and a section of wall approximately 8 ft (2.4 m) high by 50 ft (15.2 m) long collapsed onto the street below.
- In addition to the conditions described it was determined that two of the layers of geogrid had been installed with the machine direction parallel to the face of the wall.
